Trading Sand for Water – A 20-Acre Borrow Pit Became a Floodplain Lake

David W. Marshall, Jean M. L. Unmuth, Susan Graham, and Richard Wedepohl

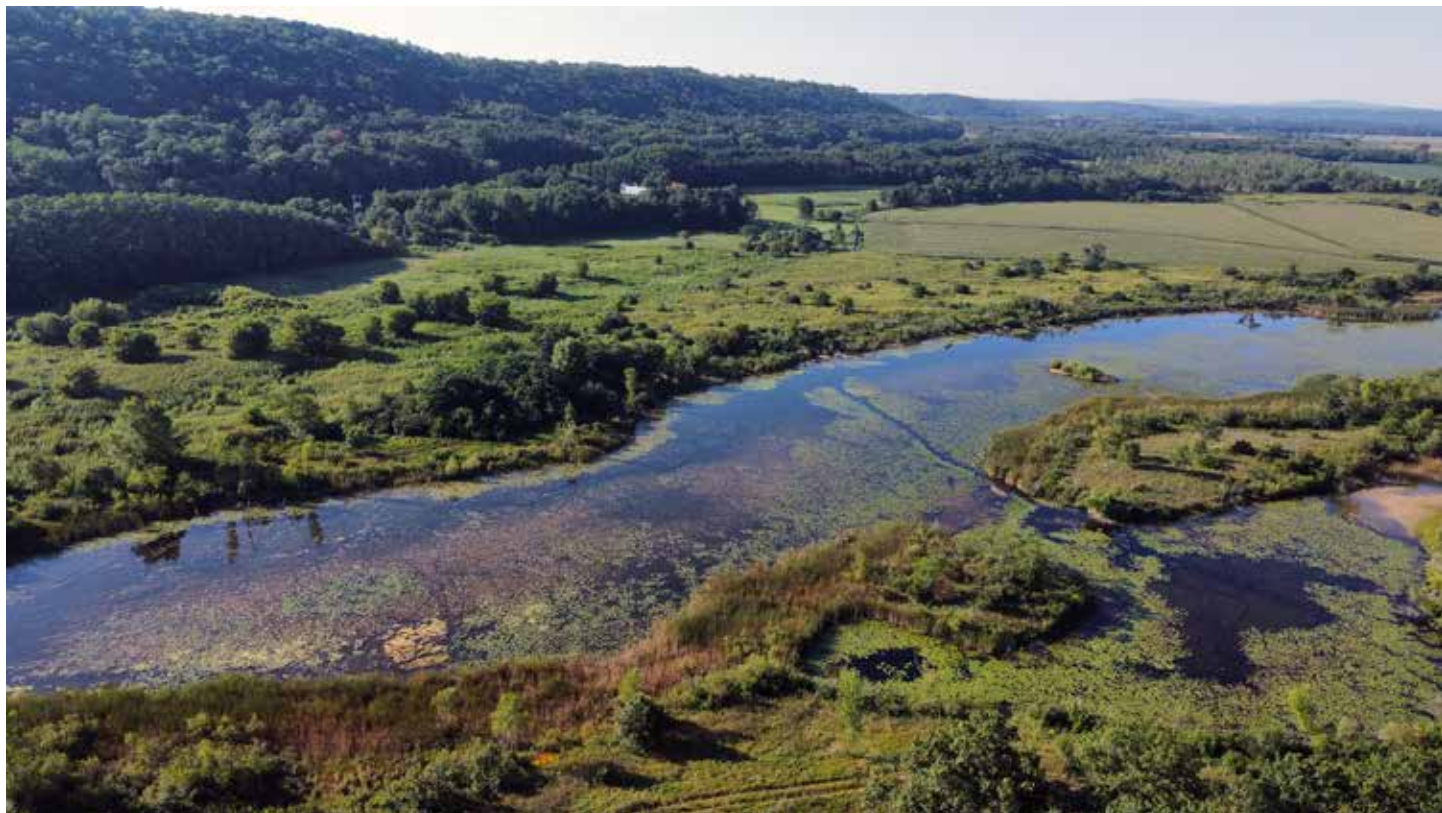
Figure 1. Drone photograph of the borrow pit lake with clean groundwater recharge area known as Blackhawk Ridge in the background. Photo by Richard Wedepohl.

Blackhawk Ridge, a publicly owned woodland where uncontaminated groundwater recharge occurs. Whereas the groundwater beneath the agricultural terraces is often contaminated with $\text{NO}_3\text{-N}$ concentrations two to three times the Drinking Water Standard, private well data upgradient of the borrow pit did not exceed 1.8 mg/l $\text{NO}_3\text{-N}$ (UW Stevens Point). The borrow pit lake's physical features and hydrology resemble most LWSR oxbow lakes, but the primary difference proved to be uncontaminated groundwater.

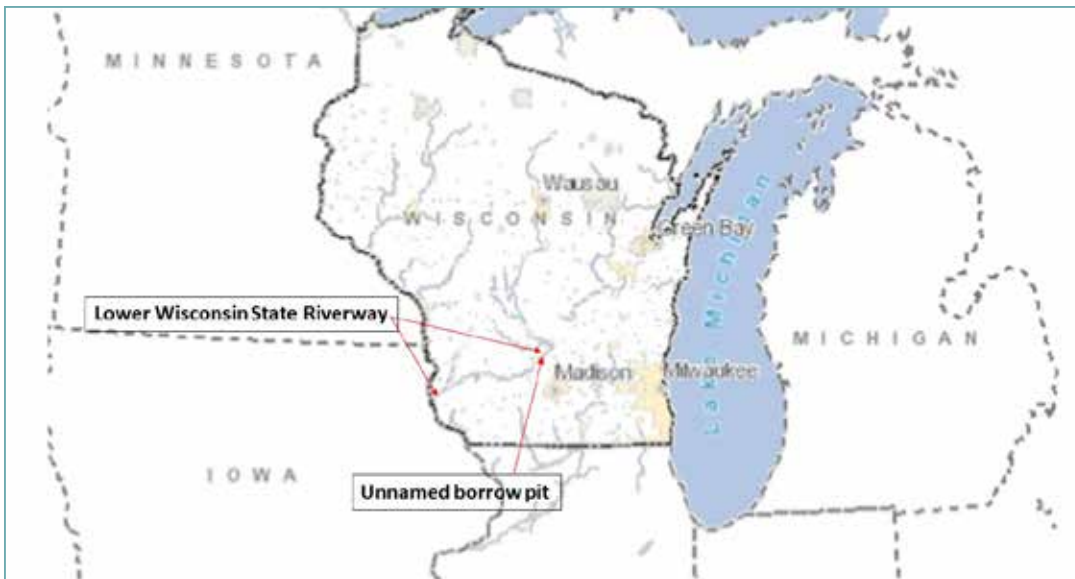
Figure 2. Overview map showing location of Lower Wisconsin State Riverway and borrow pit

The lake is located within the Lower Wisconsin State Riverway (LWSR) in southwest Wisconsin's unglaciated Driftless Area (Figure 2). The 92-mile stretch of river from the Prairie du Sac dam to the confluence with the Mississippi River is also a RAMSAR Wetland of International Importance. These designations reflect the ecological importance of a large, braided channel river along with the numerous adjoining oxbow lakes and other wetlands. Ninety-

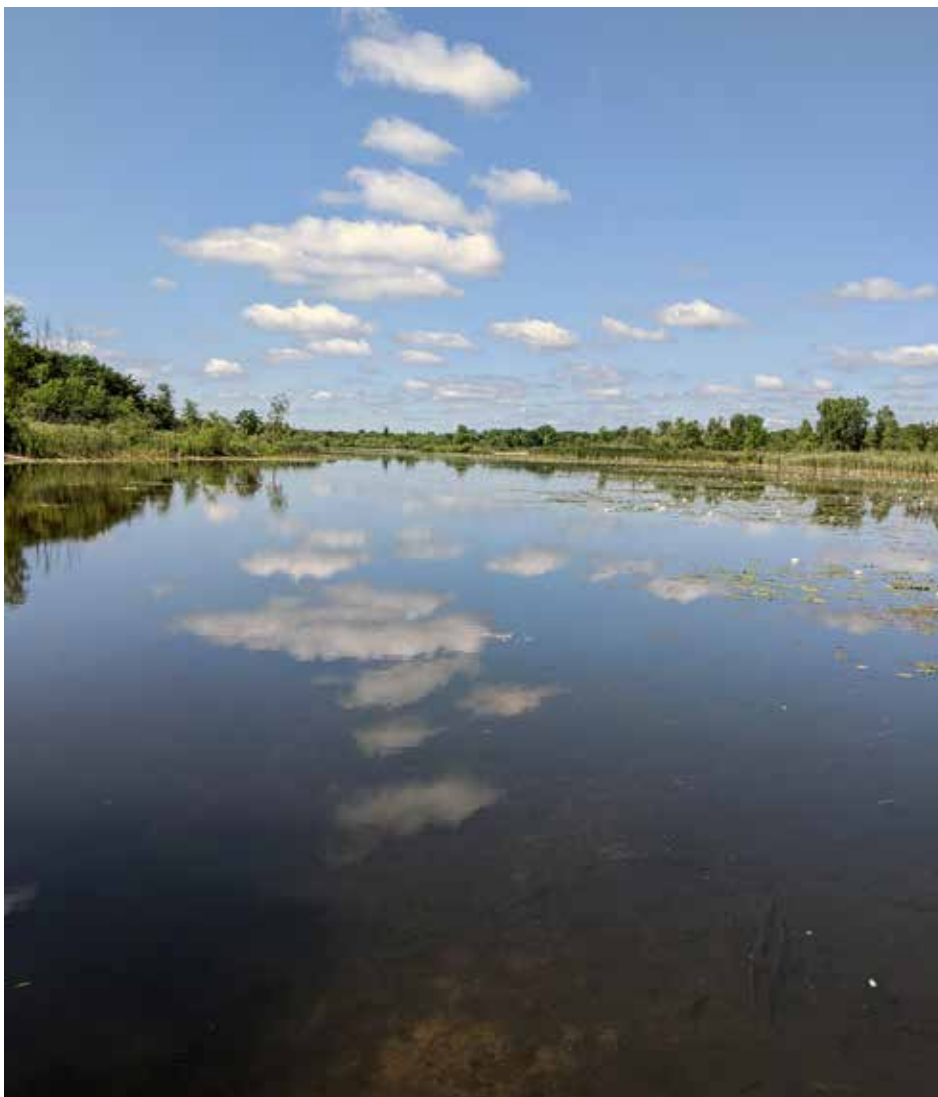
Figure 3. Borrow pit lake looking south demonstrating somewhat linear channel similar to the natural cutoff channel oxbow lakes within the LWSR. Photo by Dave Marshall

We decided to study the artificial lake for a couple of reasons. Most importantly, we wanted to know why the borrow pit lake appear healthy while oxbow lake water quality had declined across the LWSR (Figure 3). Secondly, we also wanted to explore whether creating artificial lakes is in the public interest, particularly in a high-quality river floodplain.

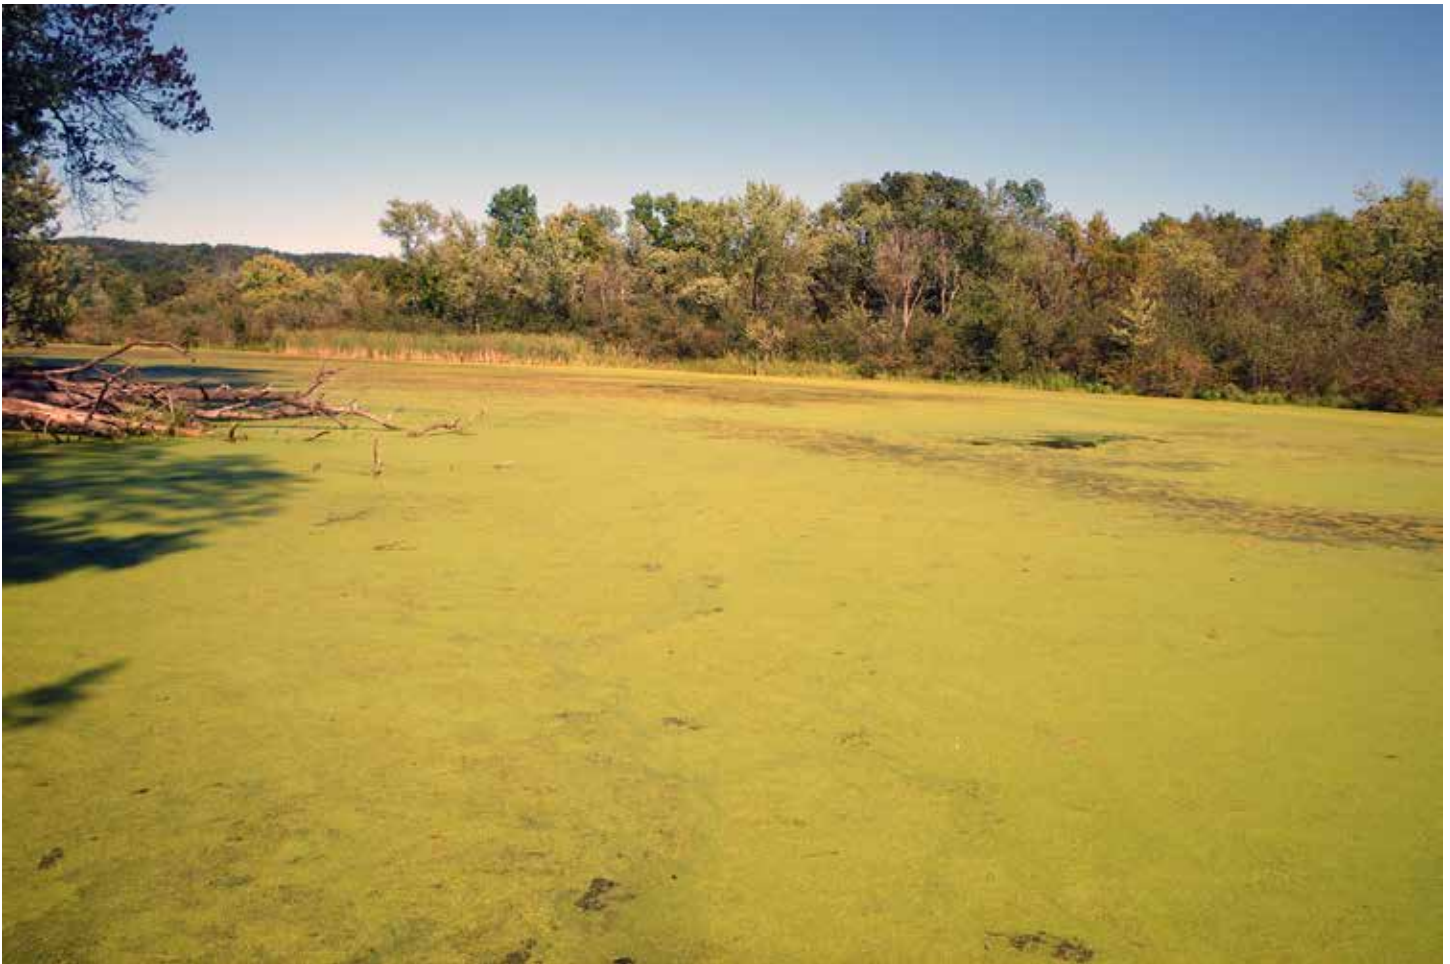
Figure 4. Photo of duckweed growth covering Jones Slough oxbow.

The oxbow lake eutrophication came in the form of dense mats of duckweeds and filamentous algae (Figure 4), collectively described as free-floating

plants (FFP). Dense FFP mats often degrade water quality and habitat and threaten many types of aquatic life. Anoxia beneath extensive FFP mats is a common problem. Under the right conditions, FFP dominance can become an alternative stable state (Scheffer et al. 2003).

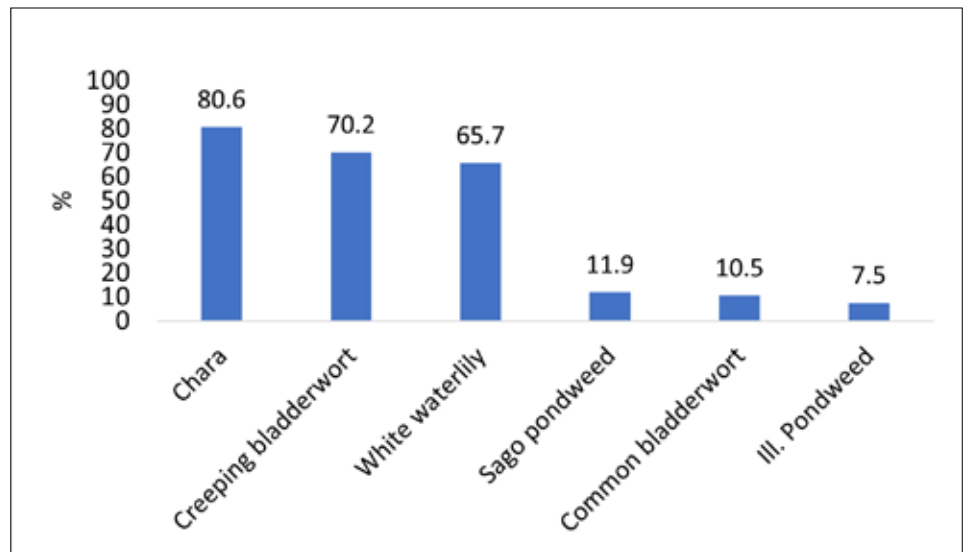
Figure 6. Summary of Borrow Pit Point Intercept Aquatic Plant Survey – Percent Frequency of Occurrence

unaltered state (Nichols 1999). The borrow pit lake had a Floristic Quality Index (FQI) value of 18.7, which is above both the median (14.3) and upper quartile (18.1) for DMR lakes. *Chara vulgaris* (common stonewort) was the most abundant plant followed by creeping bladderwort (*Utricularia gibba*) and white waterlily (*Nymphaea odorata*) (Figure 6). Duckweeds and non-native aquatic plants were not detected during the survey.

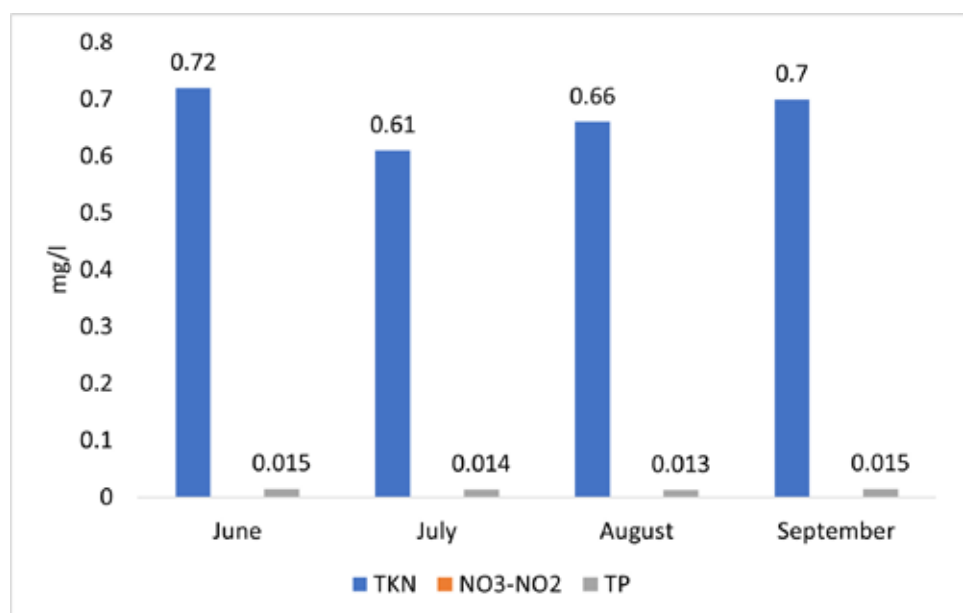
Figure 7. Borrow Pit N and P data.

We collected monthly water samples from the borrow pit from June through September and found stable conditions. Dissolved oxygen levels remained within the range of 7 mg/l to 12 mg/l. Specific conductance ranged from 417 to 496 uS/cm. pH ranged from 8.0 to 8.2. Alkalinity

ranged from 208 to 248 mg/l. $\text{NO}_3\text{-N}$ + $\text{NO}_2\text{-N}$ concentrations were below detection at the State Laboratory of Hygiene. Relatively low Total Kjeldahl Nitrogen (TKN) levels were found as was total phosphorus (Figure 7).
